TRANSPORTATION RESEARCH CENTER

**Indiana University
Bloomington, Indiana 47403-1599**

ON-SITE AIR BAG INVESTIGATION

**CASE NO. - 96-16
FLEET - PRIVATE VEHICLE
LOCATION -
ACCIDENT DATE -**

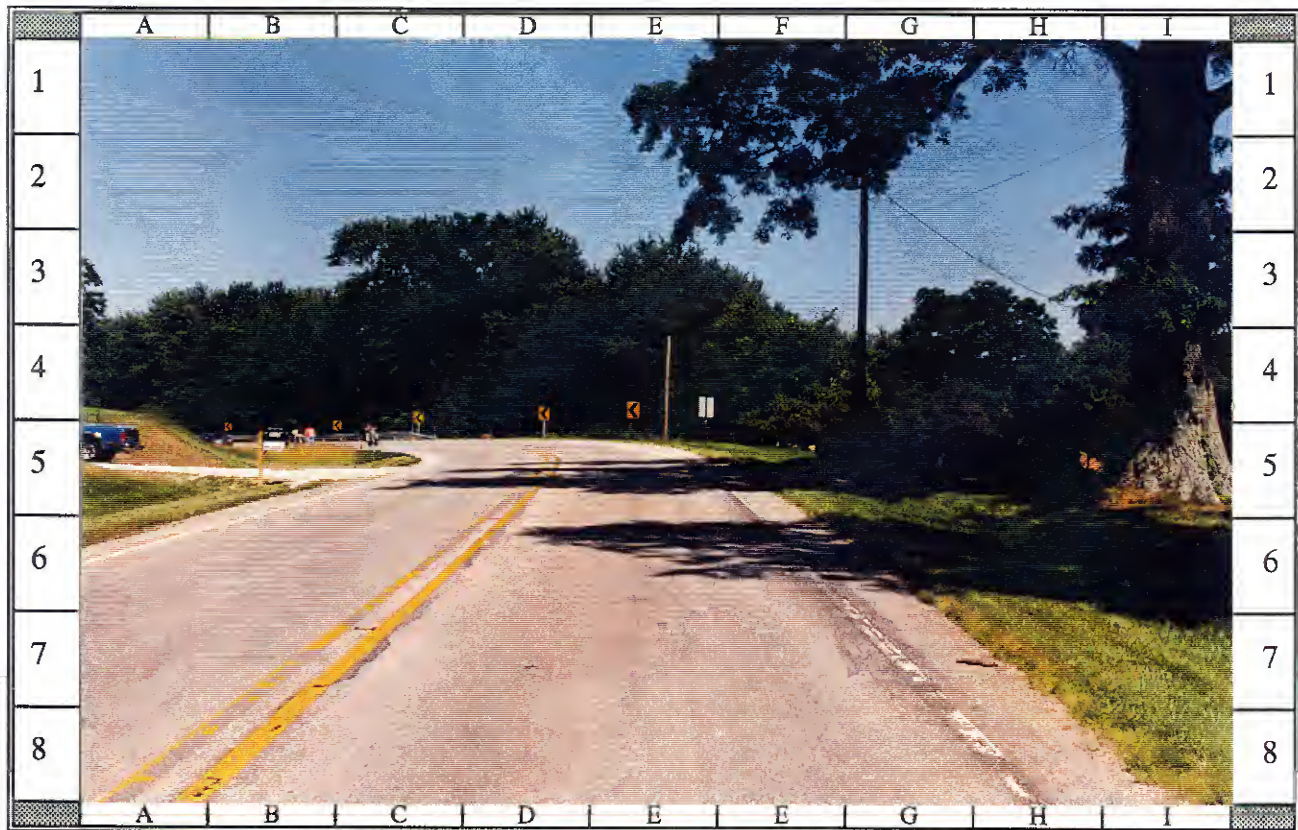
01: Case Vehicle's eastward travel path approaching left hand curve approximately 90 meters (295 feet) west of impact area

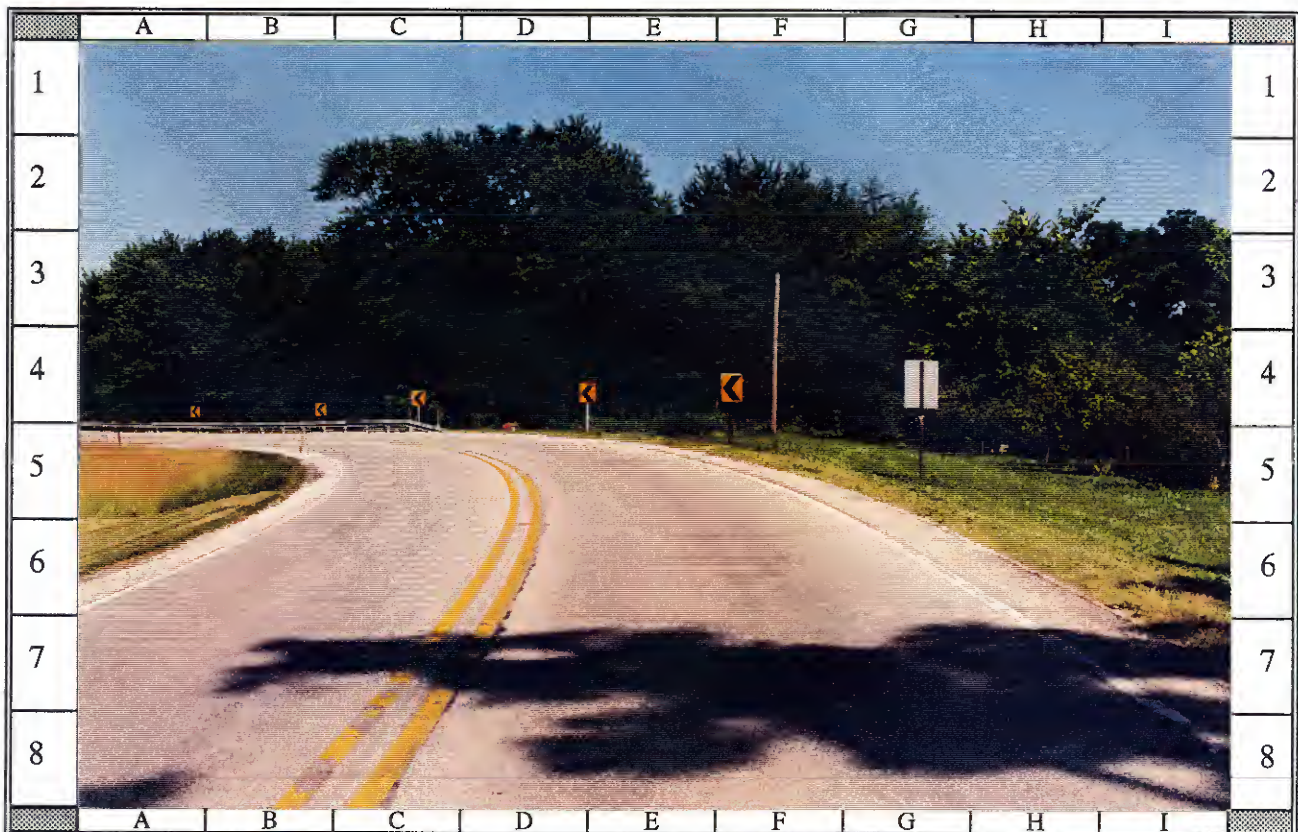
02: Case Vehicle's eastward travel path entering left hand curve approximately 60 meters (197 feet) west of impact area

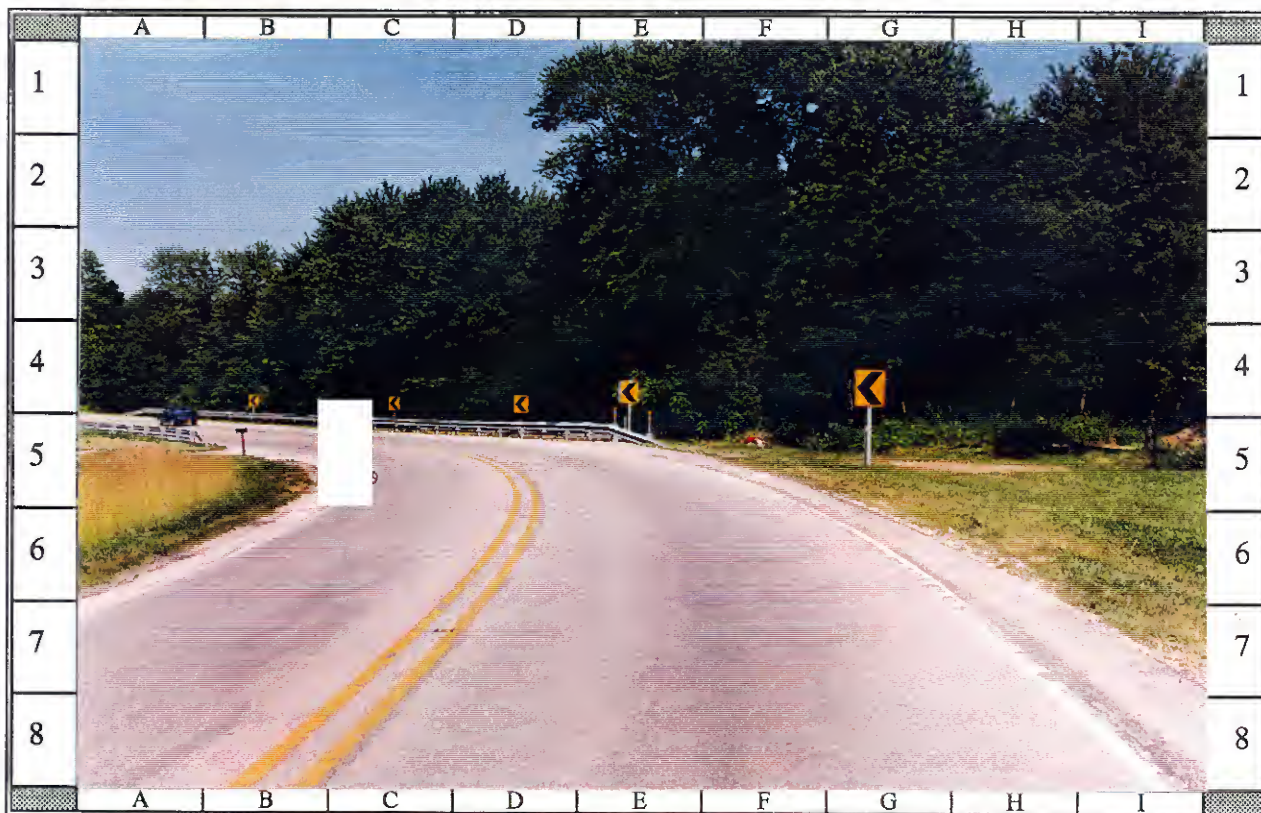
03: Case Vehicle's eastward travel path in left hand curve approximately 40 meters (131 feet) west of impact area

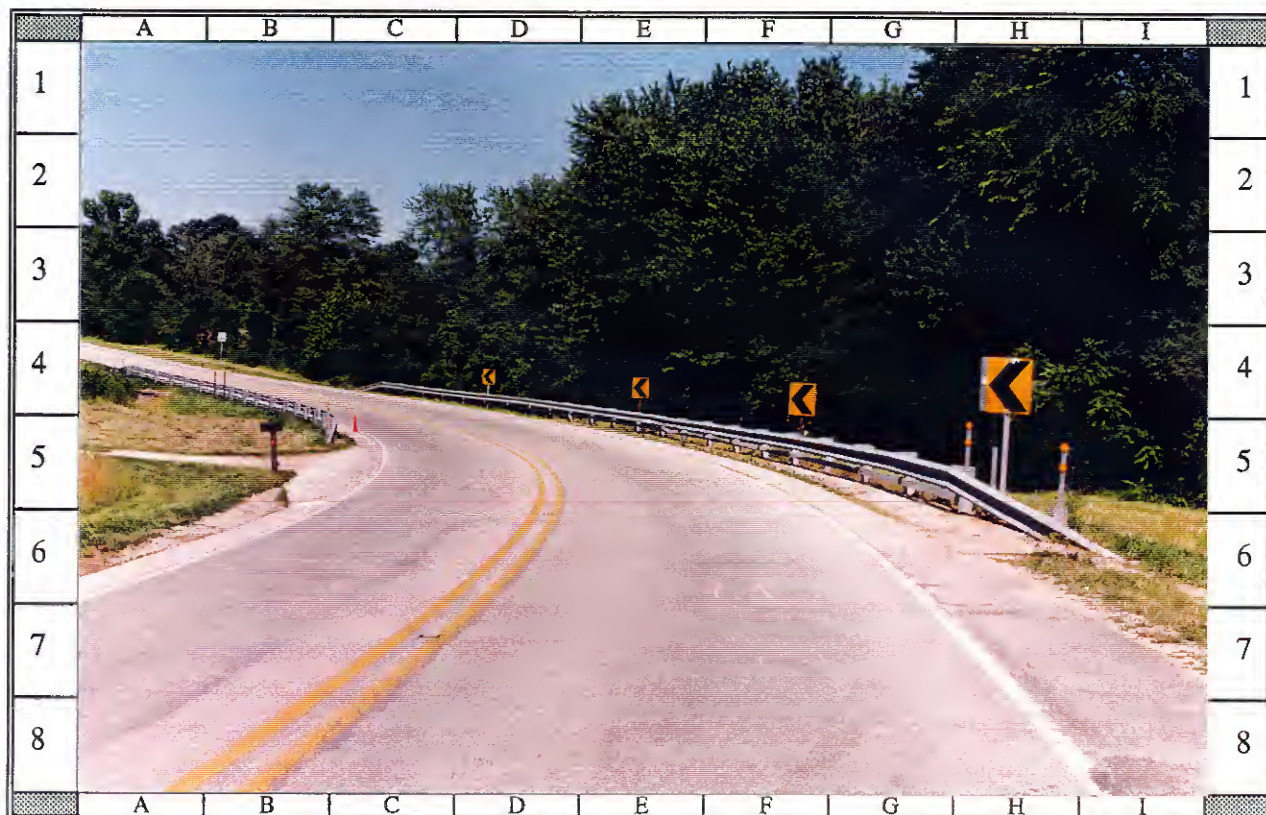
04: Case Vehicle's east-northeastward travel path approximately 20 meters (66 feet) west of impact area; NOTE: double gouges in mid-lane (cell F6)

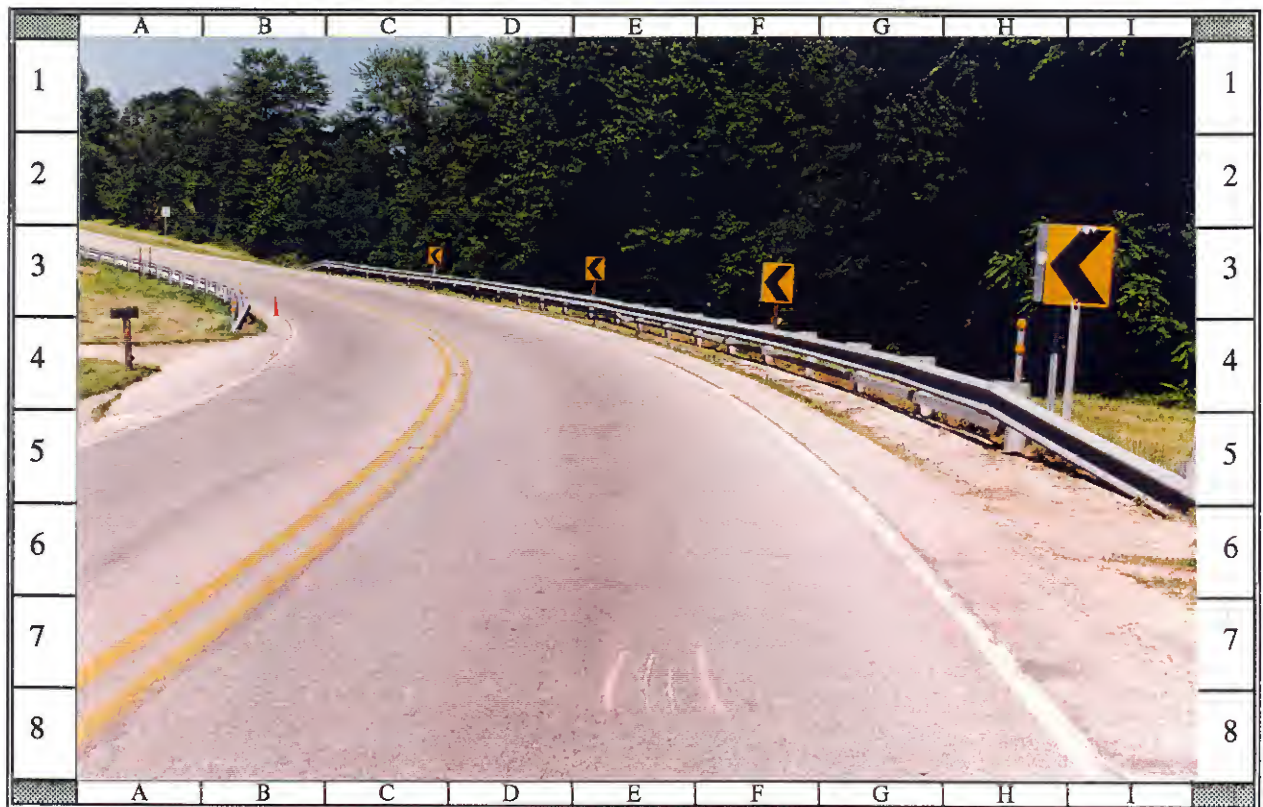
05: Case Vehicle's east-northeastward travel path approximately 10 meters (33 feet) west of impact area; NOTE: two sets of double gouges (cells E7--E8 and F5)

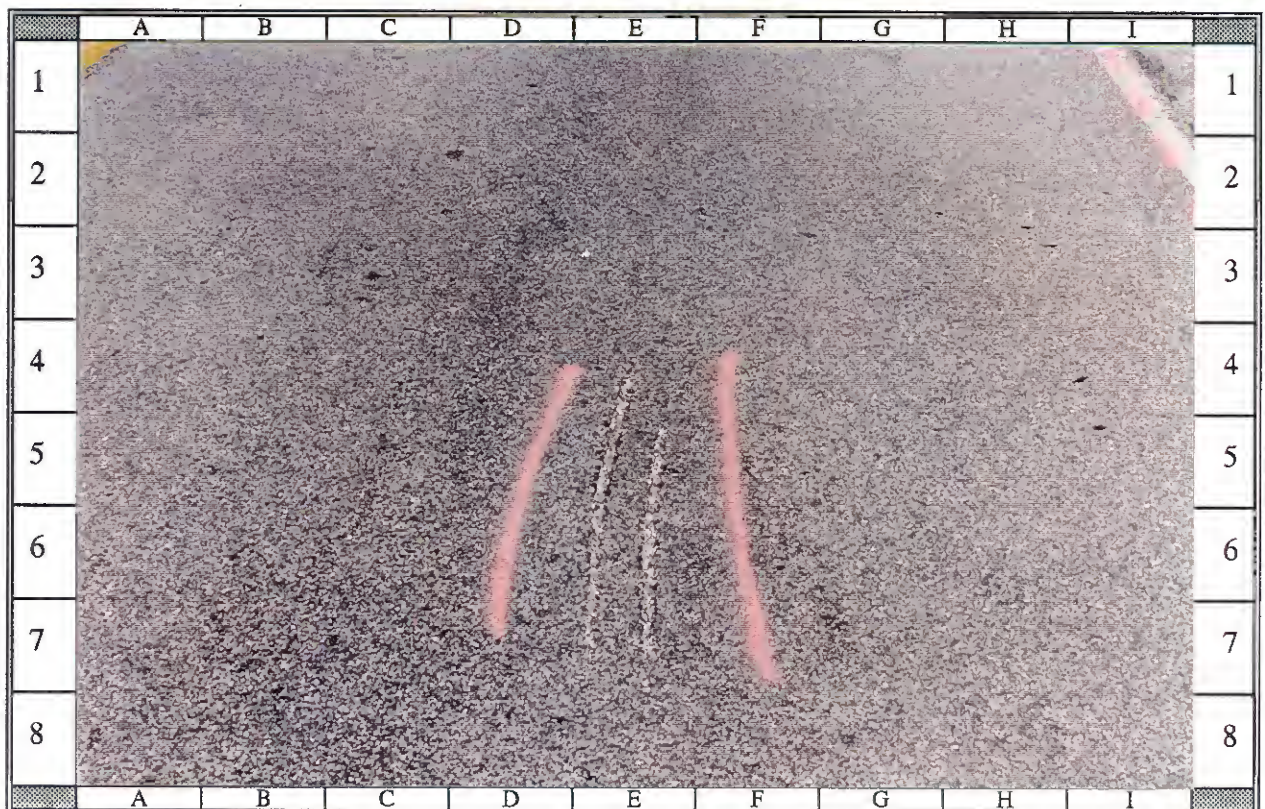
06: Close-up of double gouges in mid-eastbound lane located approximately 5 meters (16 feet) west of impact; NOTE: gouges from Vehicle #2's post-impact travel

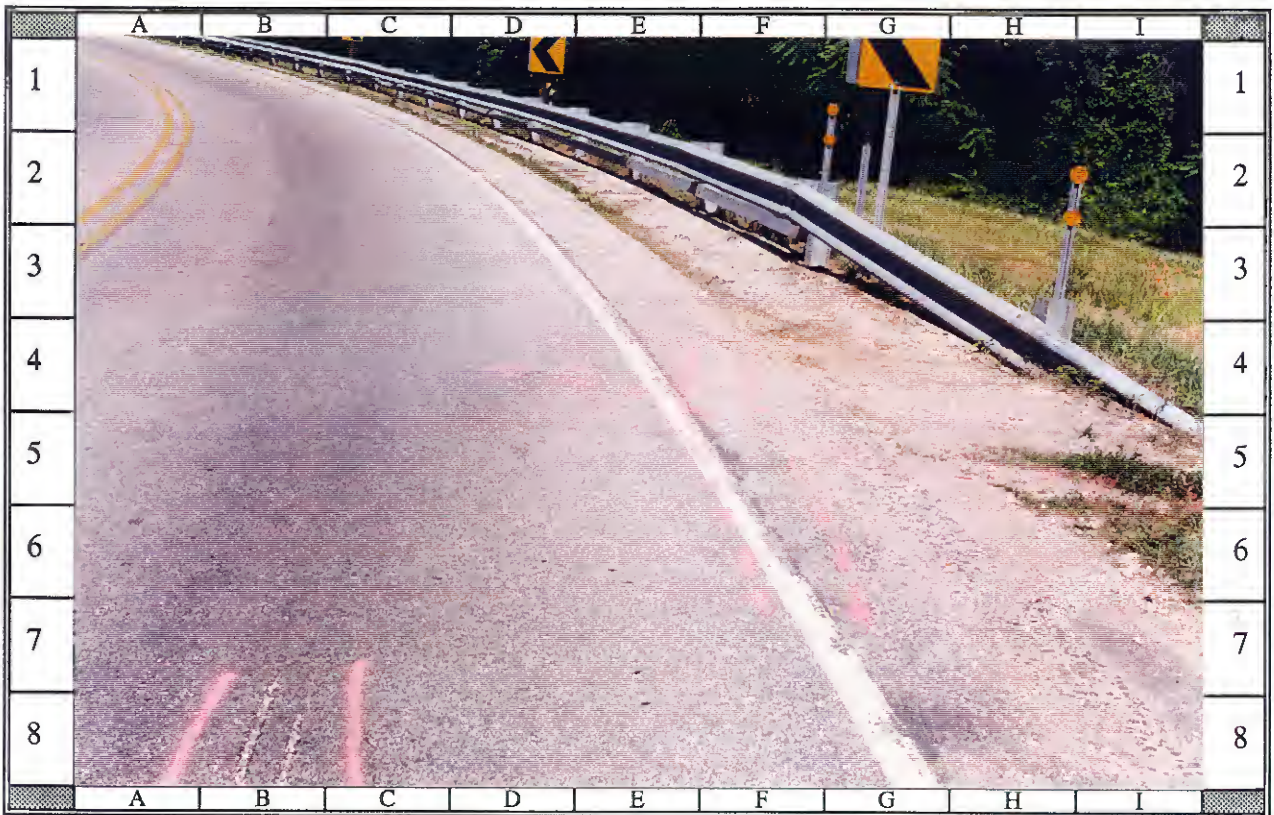
07: Case Vehicle's eastward travel path approximately 5 meters (16 feet) west of impact showing beginning of right front pre-impact skidmark on south edge line

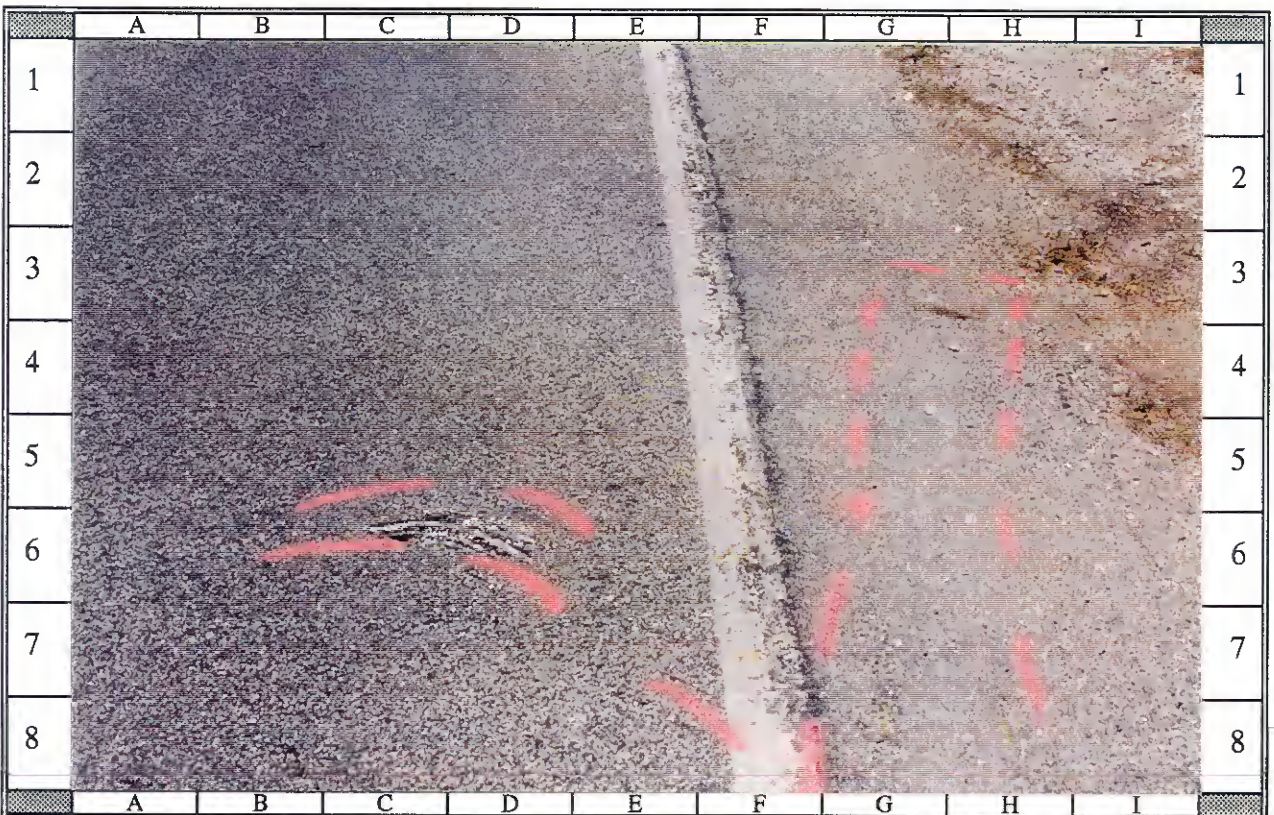
08: Eastward close-up view of Case Vehicle's impact area showing right front skidmark and parallel double gouges from Vehicle #2's post-impact rotation

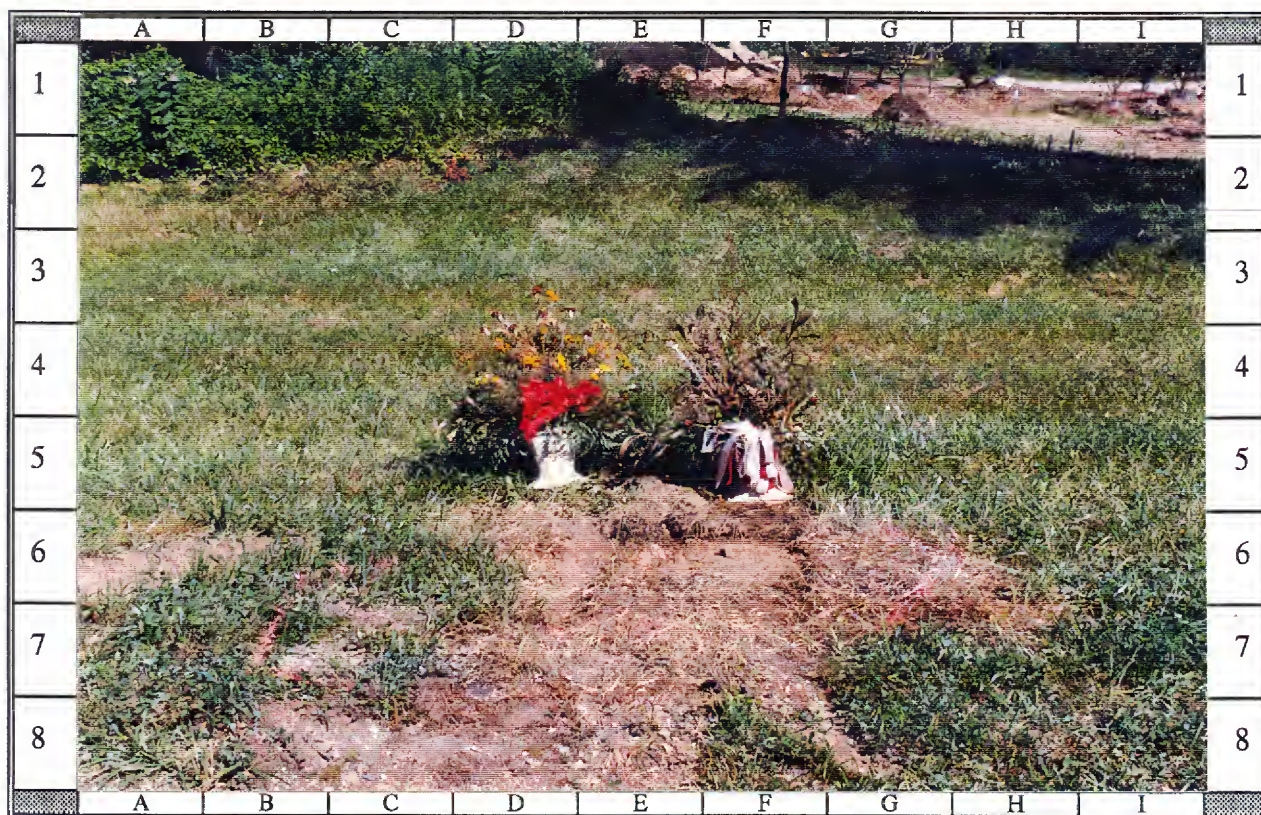
09: South-southeastward view of Case Vehicle's final rest position approximately 7 meters (23 feet) southwest of impact area; NOTE: paint locates tire positions

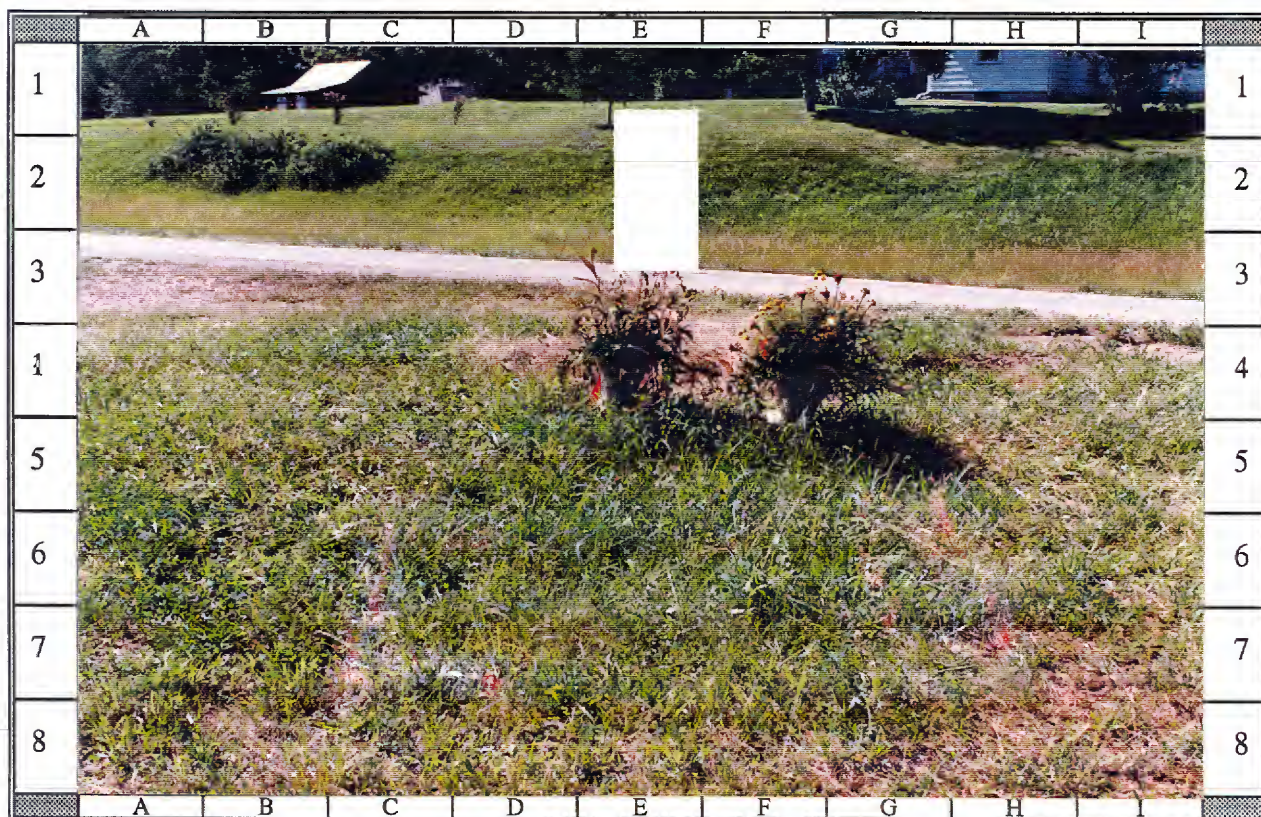
10: North-northwestward view of Case Vehicle's final rest position approximately 7 meters (23 feet) southwest of impact area; NOTE: paint locates tire positions

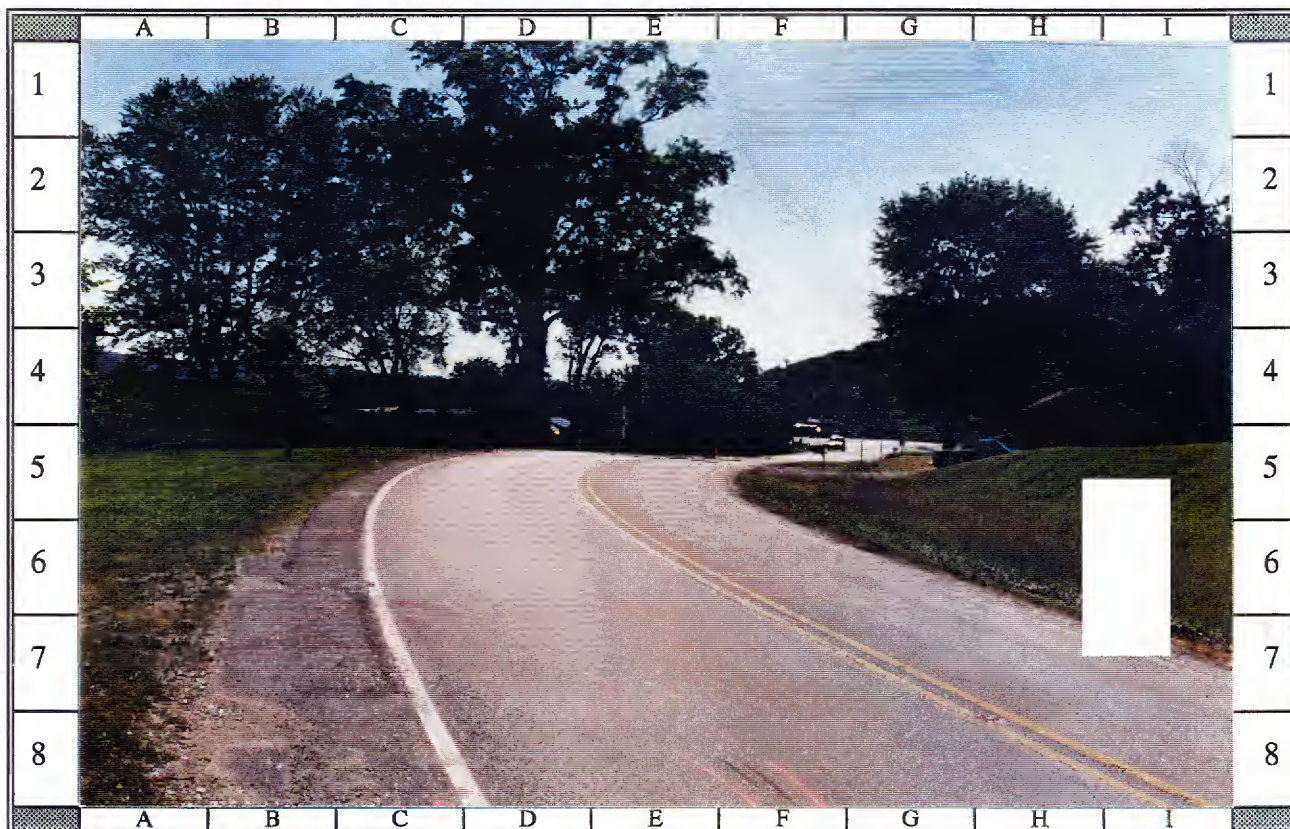
11: Westward view from impact area of Case Vehicle's eastward travel path into left hand curve; NOTE: negative slope in Case Vehicle's direction of travel

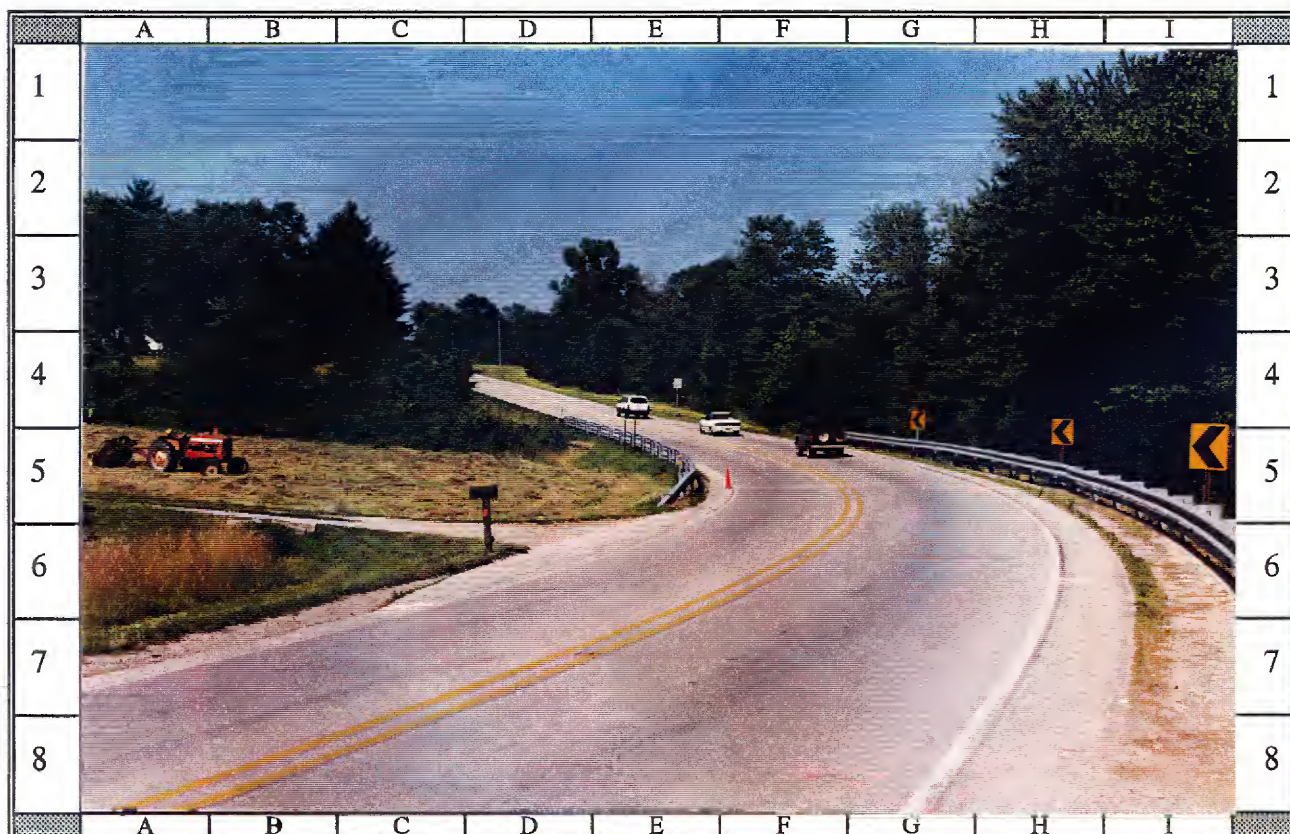
12: Northeastward view of Vehicle #2's southwest travel path in right hand curve viewed from beyond impact area; NOTE: orange cone marks location of sag

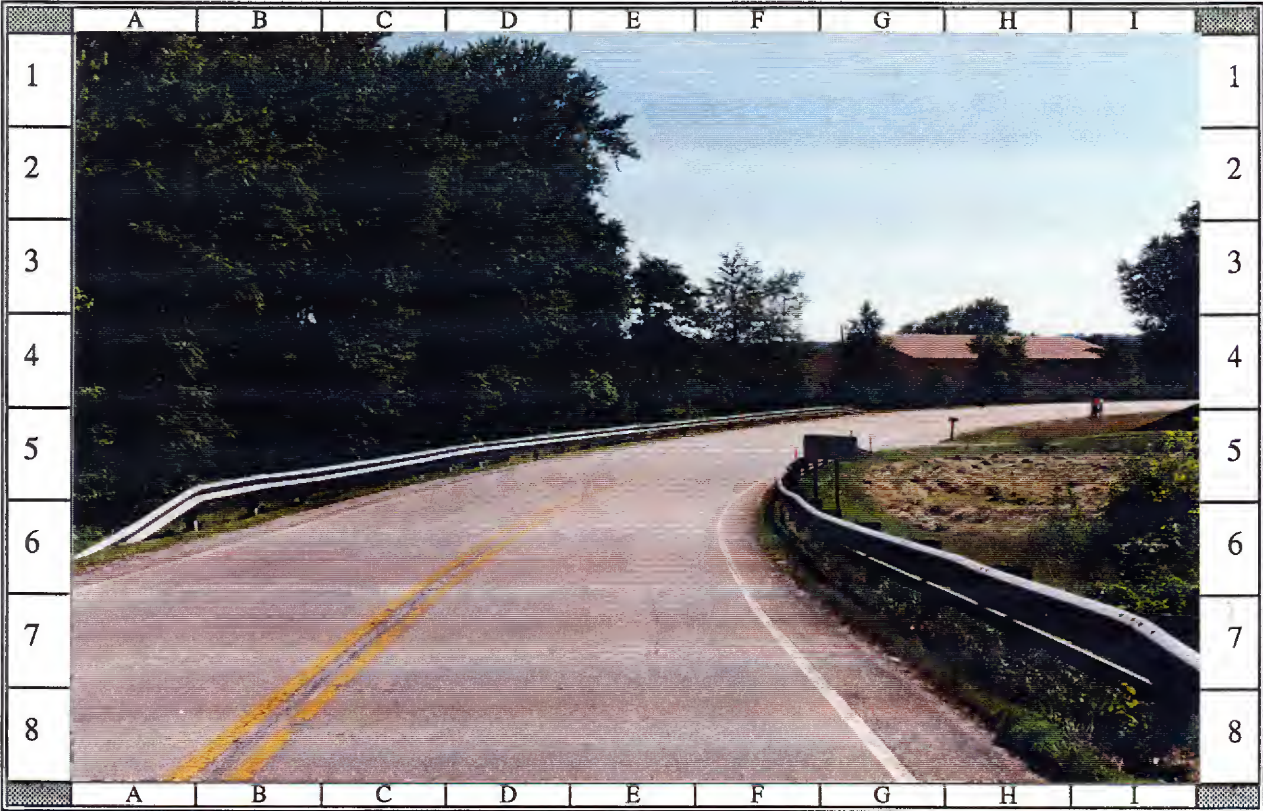
13: Vehicle #2’s southwestward travel path ~ 105 meters (344 feet) northeast of impact; NOTE: decreasing radius right hand curve and negative grade

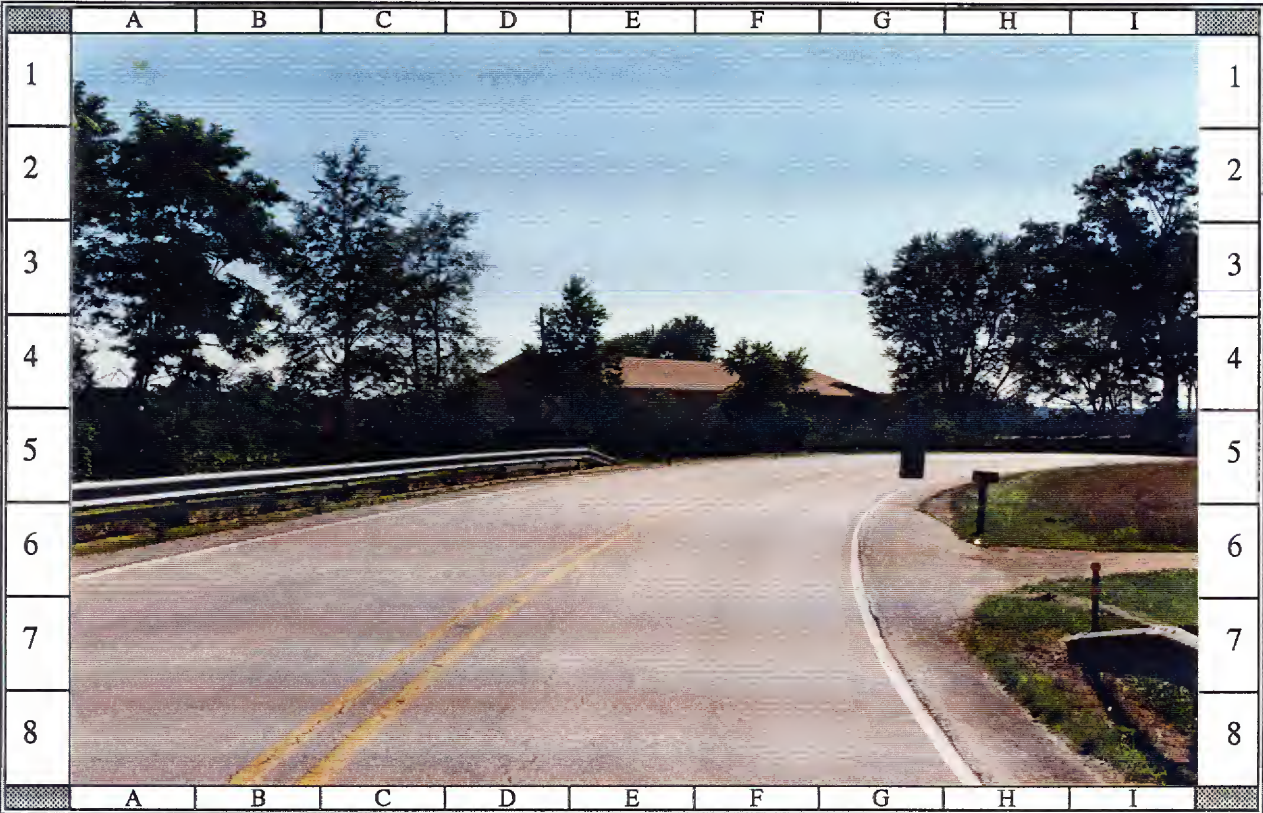
14: Vehicle #2’s southwestward travel path approximately 50 meters (164 feet) north-east of impact; NOTE: Vehicle #2 has traversed sag and grade is positive

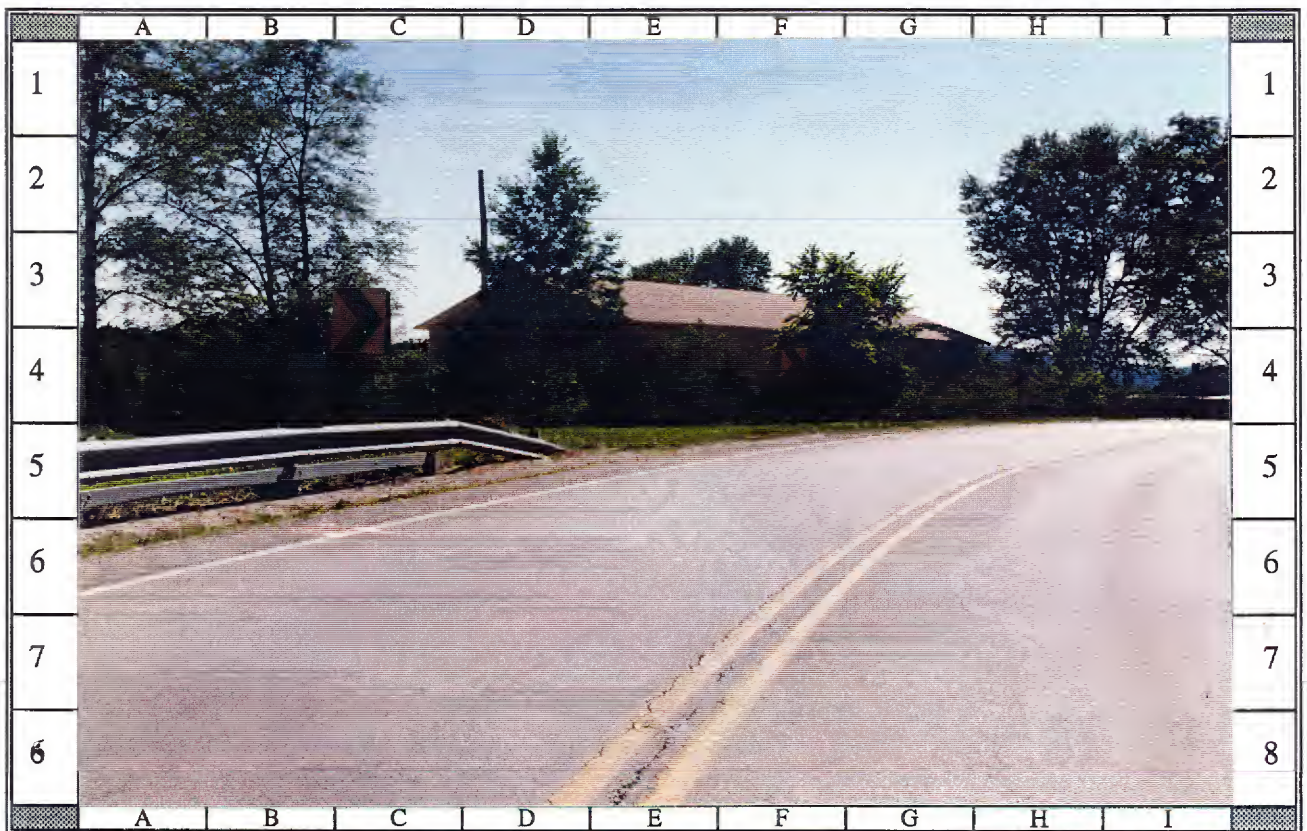
15: Vehicle #2's southwestward travel path approximately 16 meters (52 feet) north-east of impact; NOTE: impact is midway along south guardrail's end section

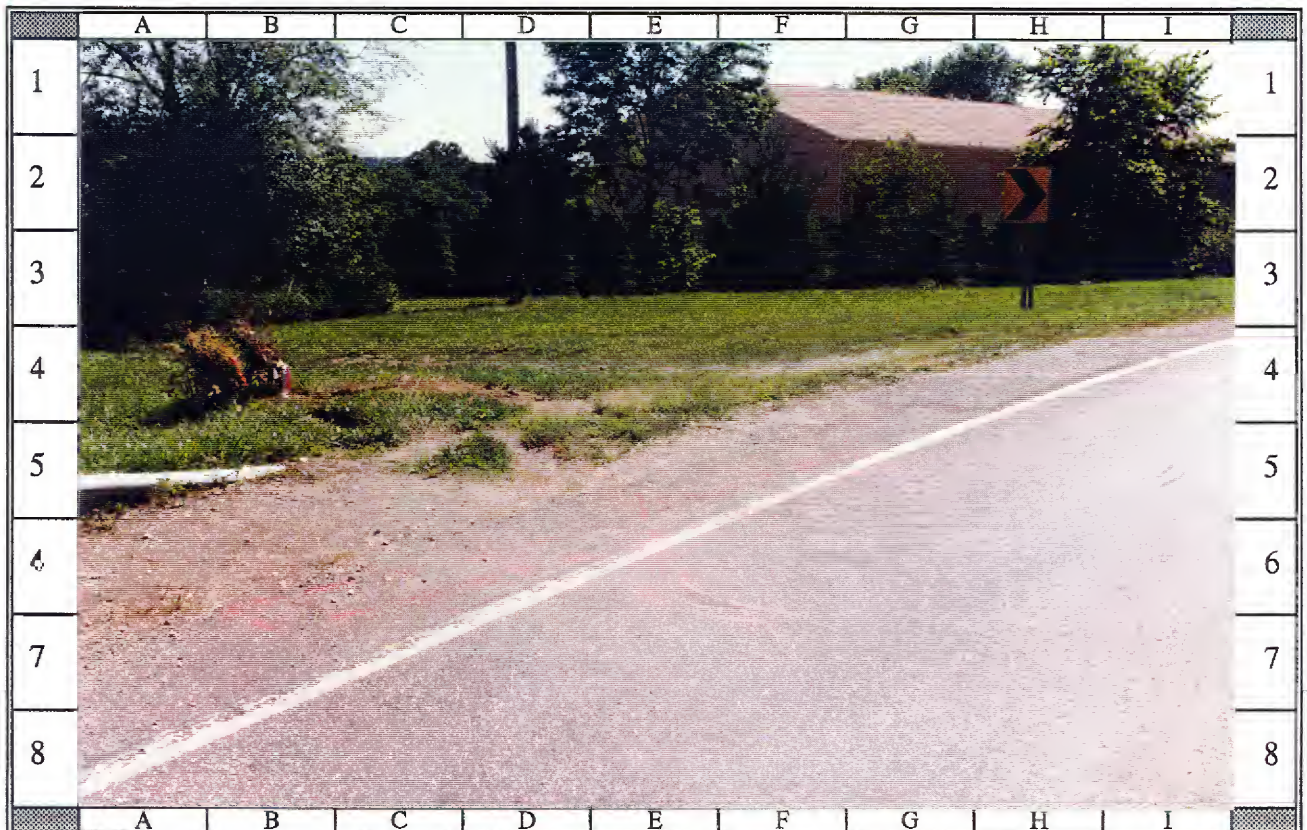
16: Southwestward view of Vehicle #2's impact area; NOTE: no pre-impact skid-marks by Vehicle #2 and final rest location of Case Vehicle in background

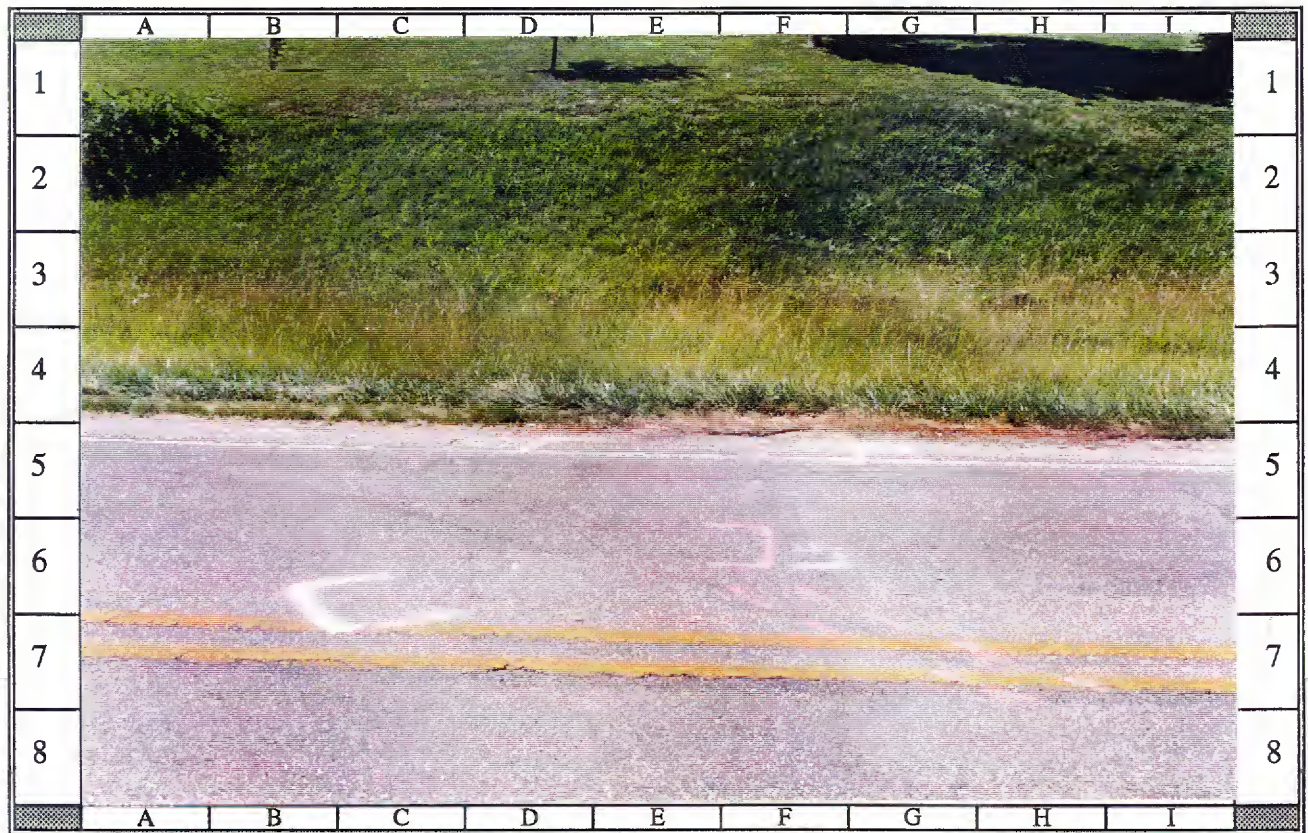
21: Northward view of Vehicle #2's final rest position perpendicular to westbound lane, heading southward; NOTE: rear tires were on the north edge line

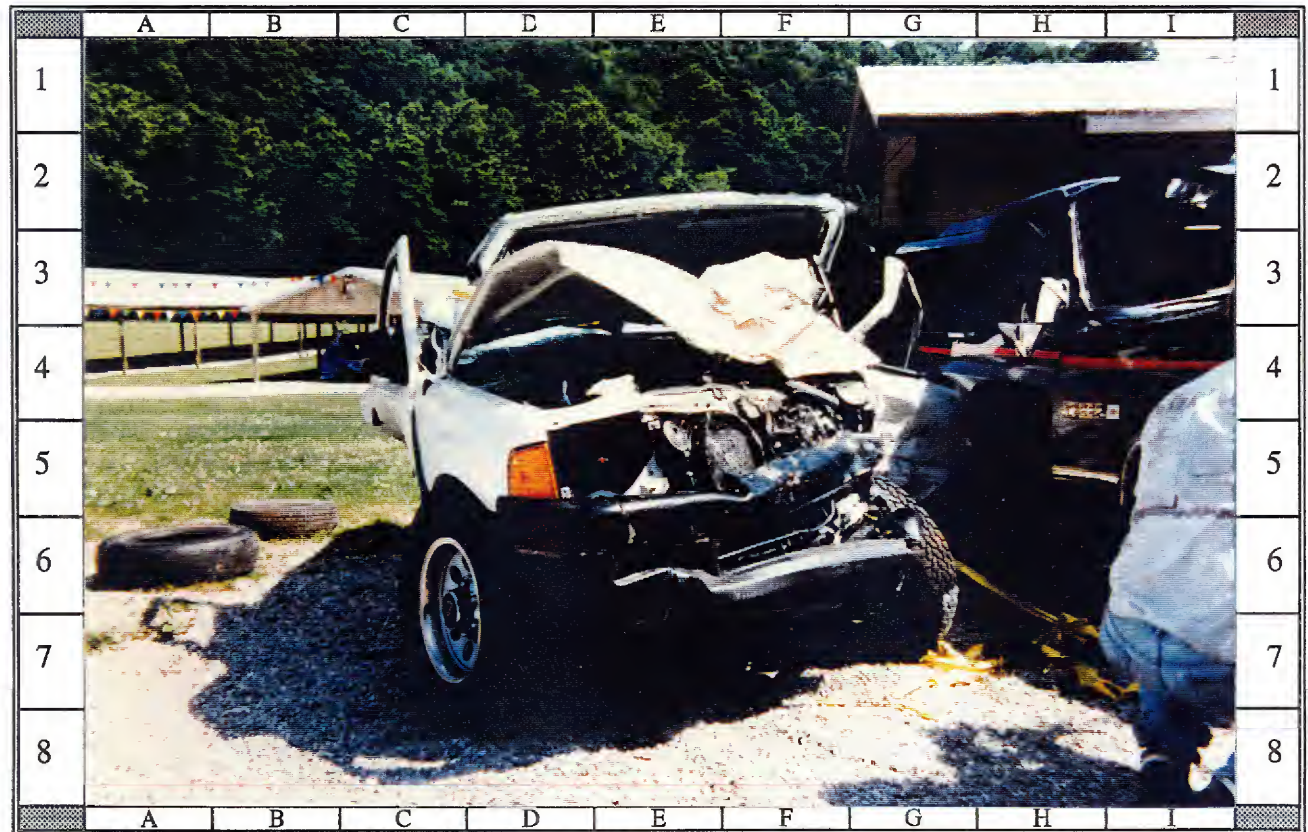
22: Case Vehicle's frontal damage viewed from front; NOTE: severe crush to front left half and leftward end shift

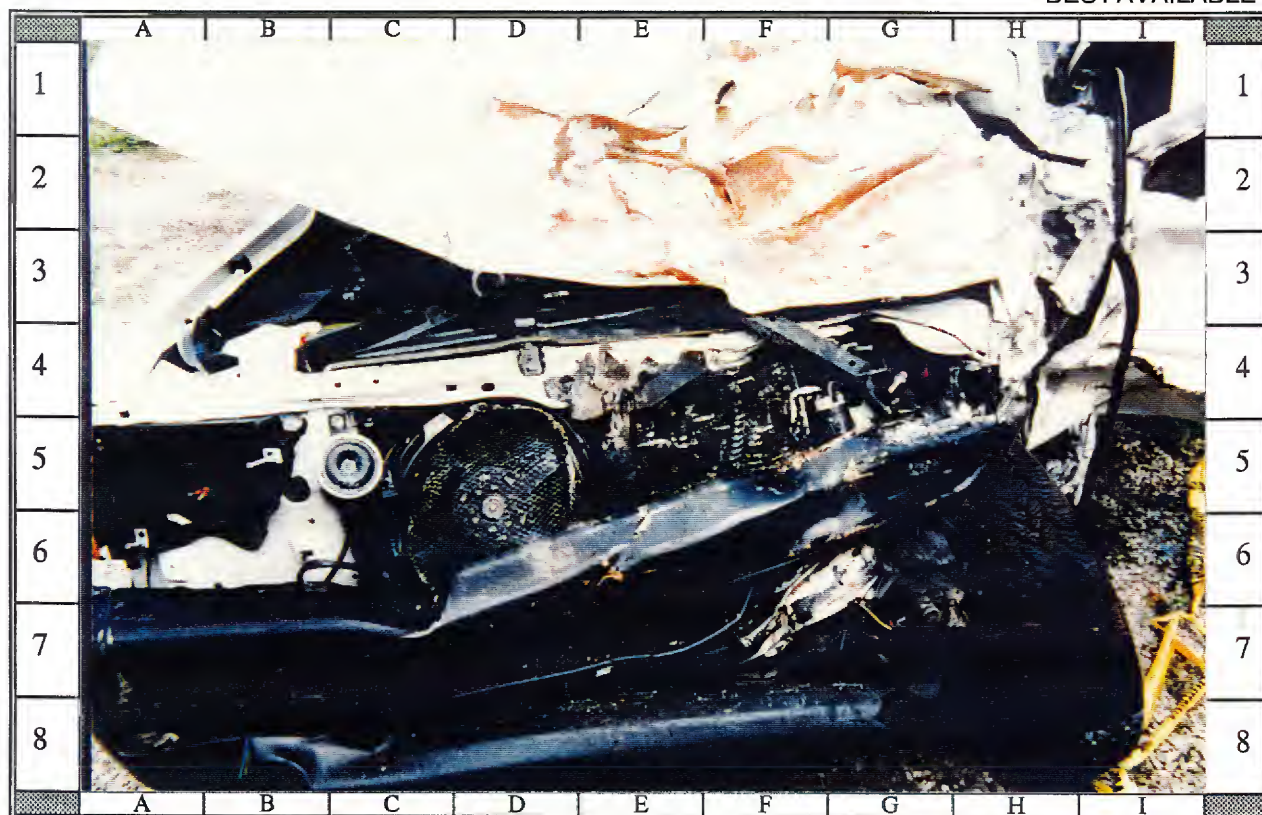
23: Close-up of Case Vehicle's front left damage viewed from approximately 30 degrees left of front

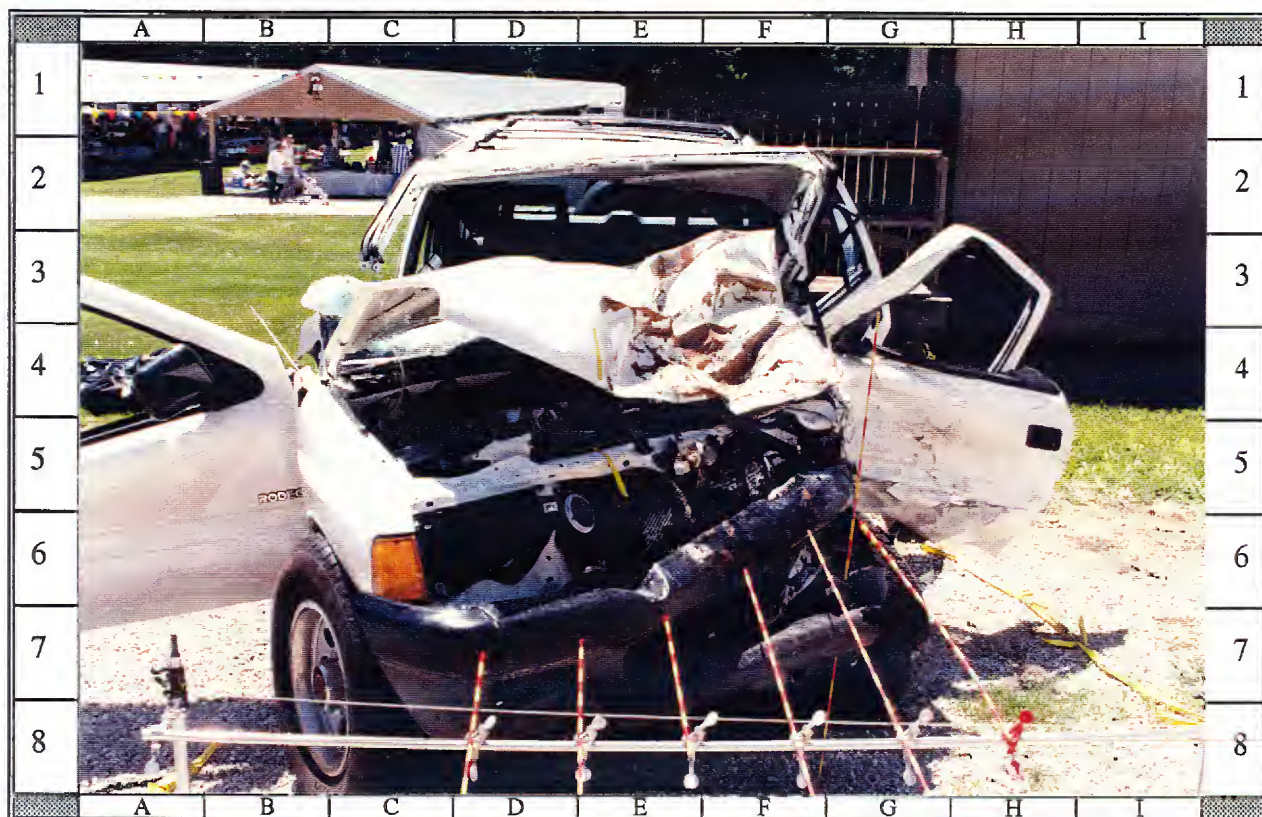
24: Case Vehicle's damaged front with contour gauge present; NOTE: direct damage extends from yellow tape (cells E4--E5) to the left front corner

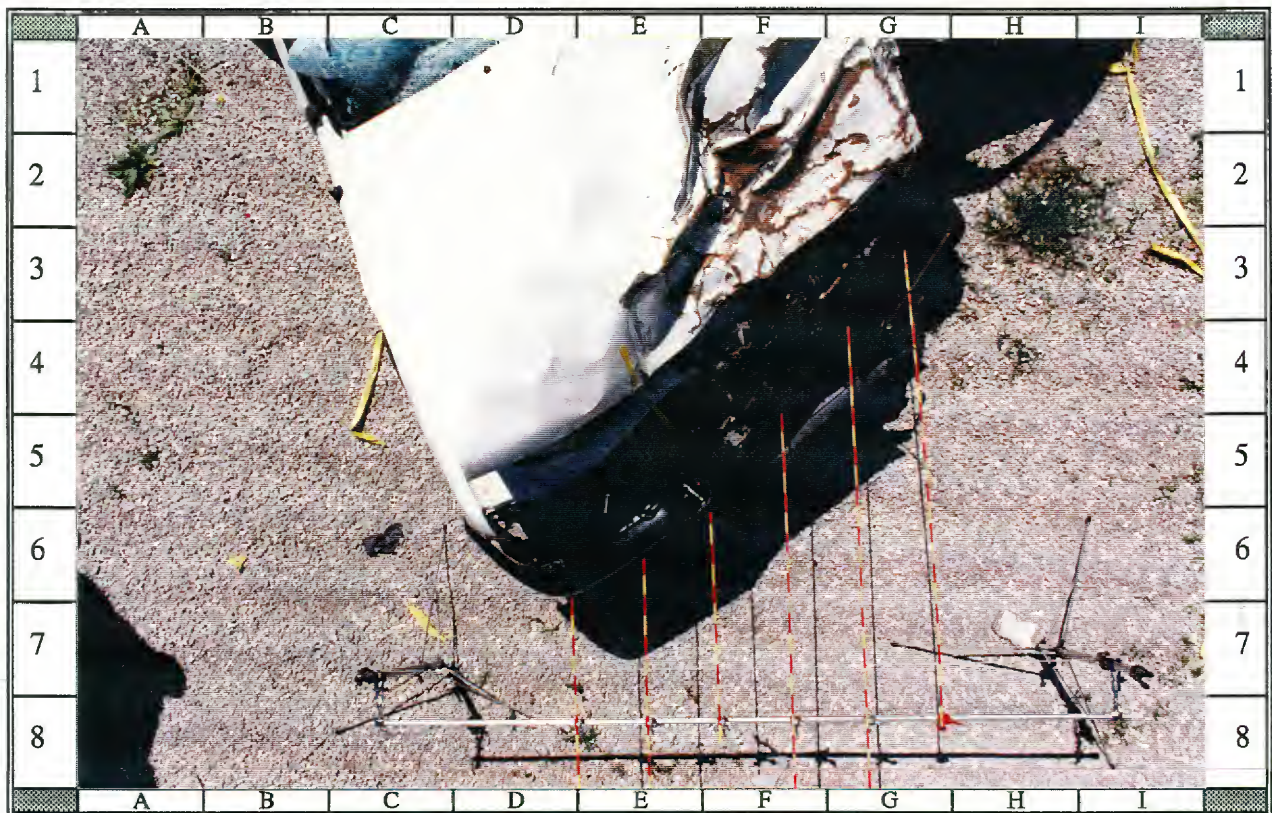
25: Overhead view of Case Vehicle's front left damage with contour gauge present showing extensive crush to front-left corner and leftward end shift
